PROPERTY INSPECTION REPORT

3505 Timbercreek Ct Sachse TX 75048

Date of Inspection: 5/3/2022

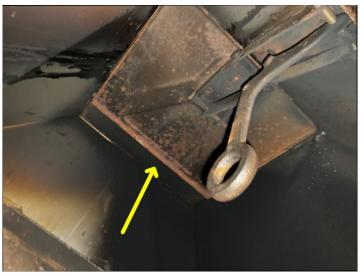
It is required for safety when you have gas burning logs to have a damper clamp attached to your damper so that the flu will not close all the way allowing carbon monoxide gas to escape when running the gas fireplace.
